PROYECTO FINAL DE CARRERA

Patología estructural y del casco:

Métodos de protección, inspección, mantenimiento y reparación

Ingeniería Naval y Oceánica
Junio, 2014

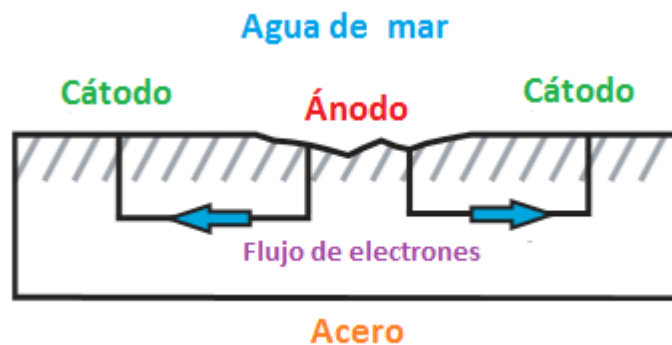
Figura 3.1: Flujo de electrones en el acero

Toda la zona metálica es por lo tanto dividida en un largo número de ánodos y cátodos, como puede verse a continuación.

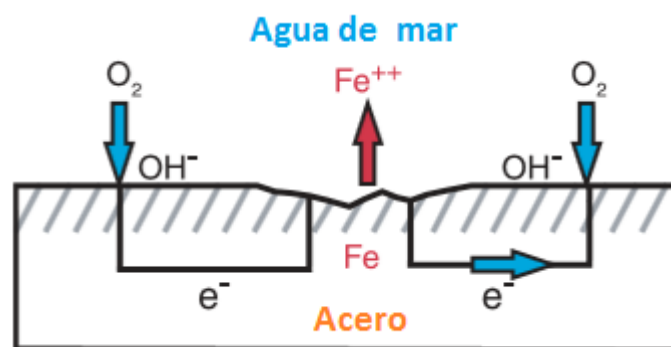
Figura 3.2: Reacción anódica en el acero

Así como la reacción anódica puede dar lugar de forma mucho más rápida que la reacción catódica, la mayoría de la superficie da lugar a la producción de iones como se ve en la siguiente figura.

Esta figura muestra el proceso de corrosión en el cual el metal es perdido desde el ánodo, causando un desgaste en el mismo y dando lugar a una zona de menor espesor.

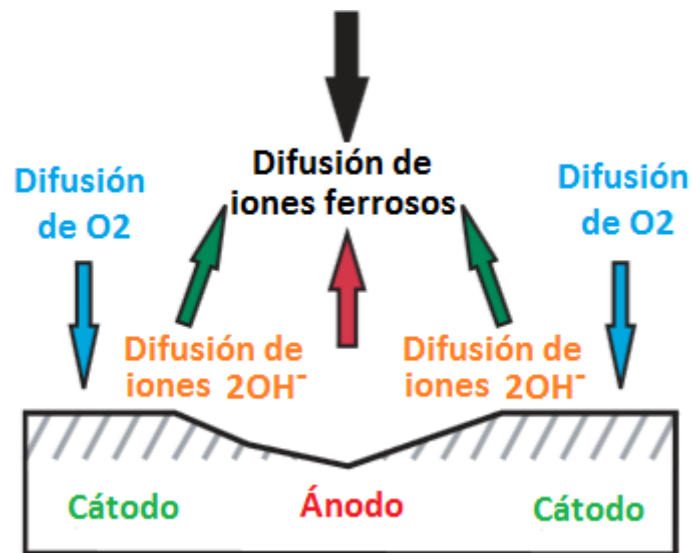
Figura 3.3: Difusión de iones ferrosos

1. Difusión: la corrosión está ligada directamente por la difusión de oxígeno que se da lugar a través del agua a la superficie del acero. En áreas donde la difusión del oxígeno es frecuente, la corrosión tiene lugar de forma más continua y rápida.

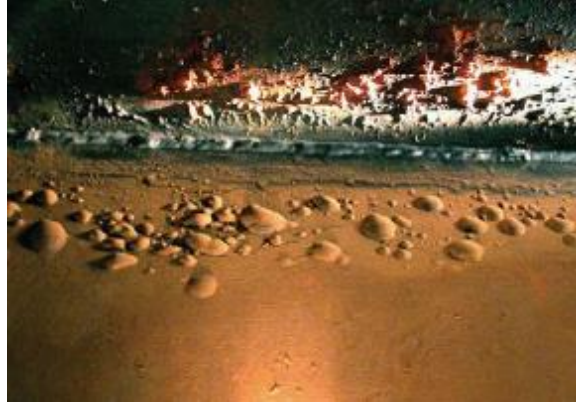
Figura 3.4: Pitting

Un modo común de corrosión por pitting es el dado por un anillo de burbujas alrededor de una zona anódica activa, como puede apreciarse en la siguiente figura.

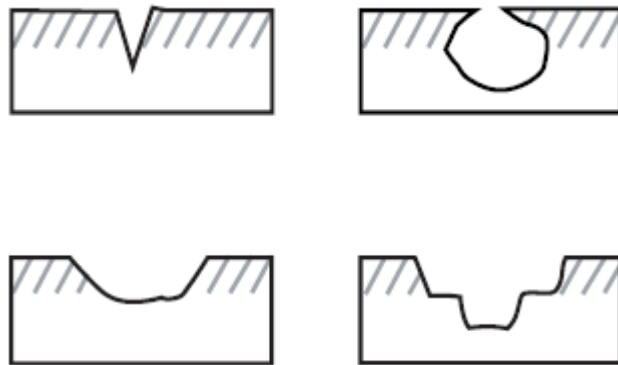
Figura 3.5: Formas de pitting

Este tipo de corrosión puede darse en distintas formas, como son por ejemplo:

El primer tipo de pitting es muy peligroso debido a que el ratio de penetración a través del acero puede ser muy elevado. Una vez este tipo de corrosión ha dado lugar, es muy difícil de eliminar la corrosión de la base de la hendidura y además el ratio de velocidad de corrosión aumenta de forma elevada.

El segundo tipo de corrosión tiene también un alto peligro, debido a que la corrosión aparente parece menor de lo que en realidad es debido a que la corrosión bajo la superficie tiene un área mucho mayor de la visible aparentemente y esto puede provocar una rotura si la superficie se ve afectada por una carga o presión, dando lugar a una apertura. Pero, si no se da lugar la apertura el ratio velocidad a la que la corrosión incrementa se verá aumentado

Las otras dos formas de pitting son dañinas para la superficie, puesto que ningún tipo de corrosión es favorable, pero los efectos y consecuencias de las mismas son menores debido a su poca penetración en la superficie y su fácil apreciación.

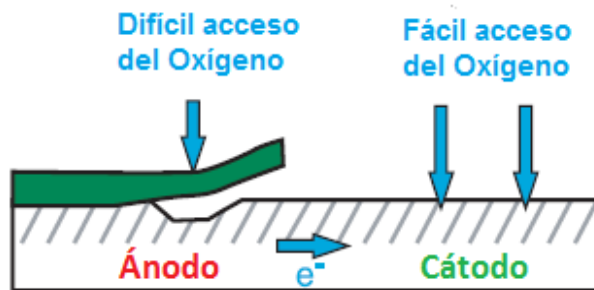
Figura 3.6: Corrosión por grietas

3. Corrosión por grietas: este tipo de corrosión es una corrosión localizada, que se produce con una configuración geométrica en la estructura en la que el cátodo reactivo, oxígeno, puede acceder de forma sencilla a la superficie del metal fuera de la grieta y tiene una mayor dificultad de acceso en la zona de la grieta. El metal alojado en la grieta será la parte anódica de la zona circundante a éste y por lo tanto sufrirá la mayor corrosión.

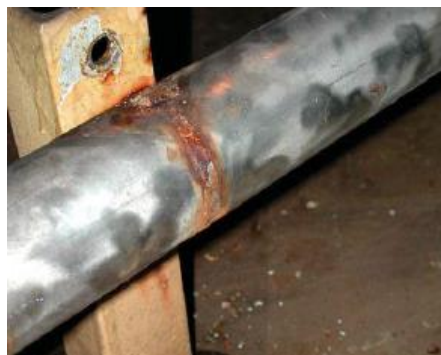
Figura 3.7: Ejemplo real de corrosión por grietas

También puede ocurrir entre una estructura metálica y un elemento no metálico como puede verse en la siguiente imagen:

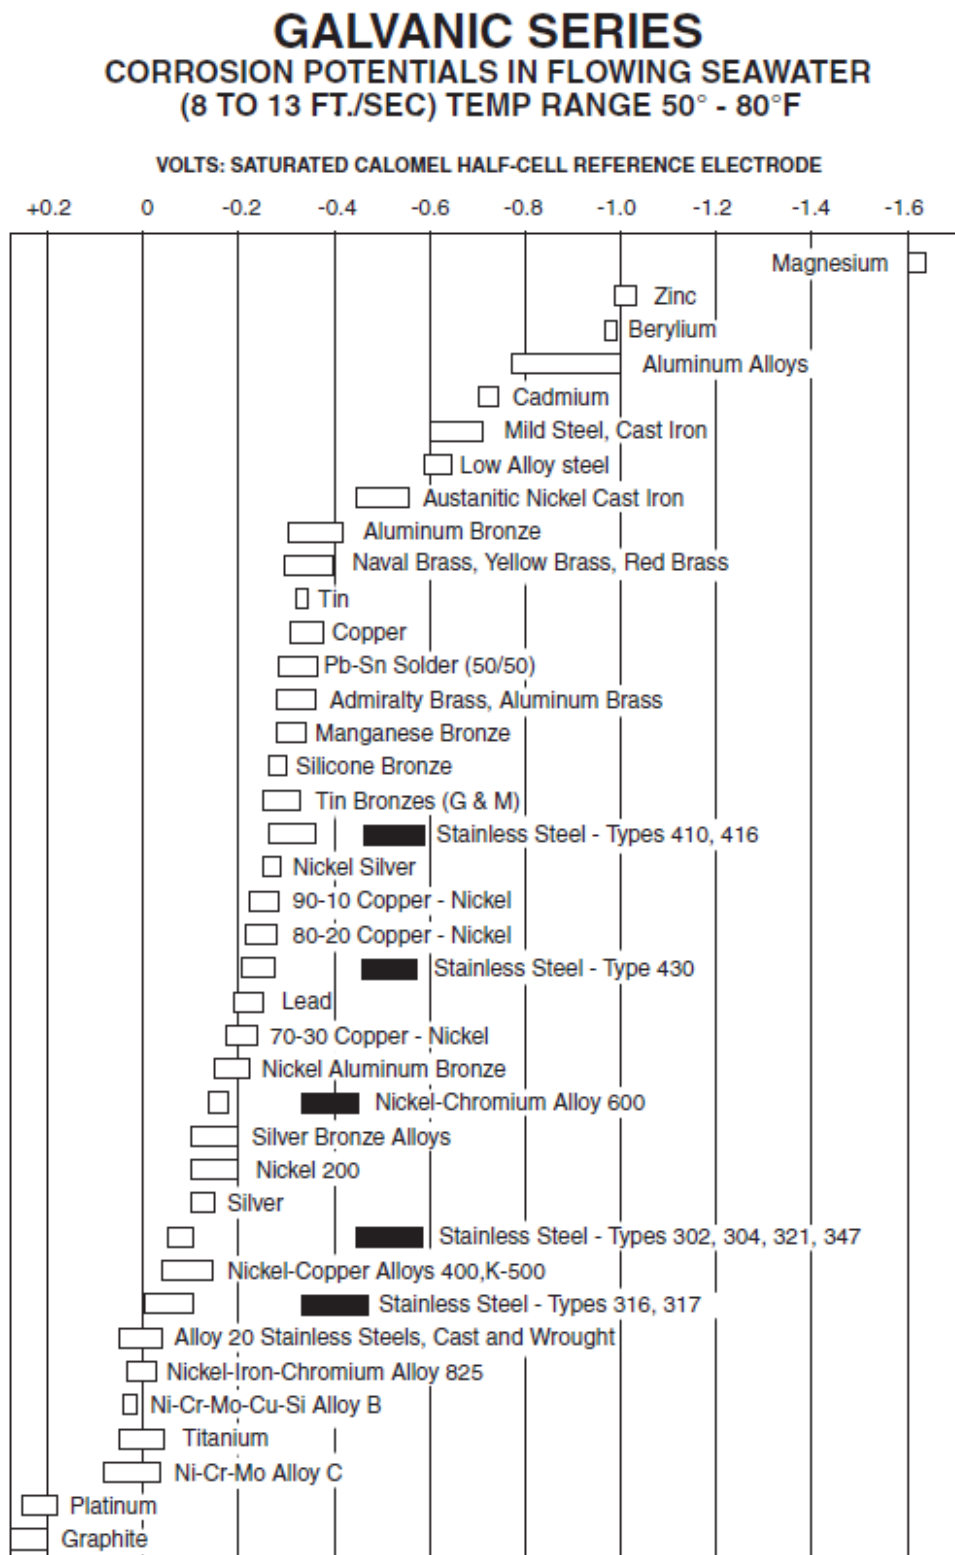
Figura 3.8: Tabla de potencial galvánico

Para determinar el potencial galvánico se utilizan las series galvánicas, referenciadas al potencial SCE. El metal con mayor carga positiva (noble) será protegido de la corrosión por el material con mayor carga negativa (base).

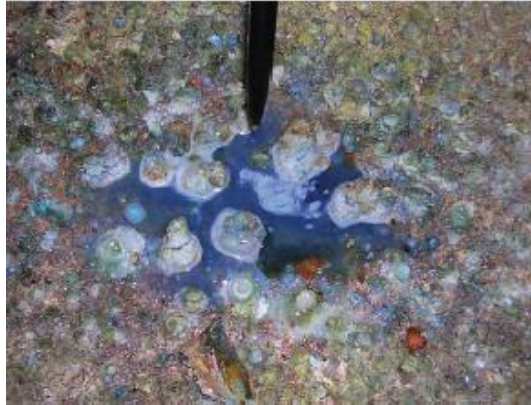
Figura 3.9: Corrosión por deposición

5. Corrosión por deposición: este tipo de corrosión ocurre cuando los iones de un metal con mayor carga positiva entra en contacto con uno de mayor carga negativa, y el metal más noble se deposita. El resultado es una mezcla galvánica local formada y la corrosión del metal menos noble. Un ejemplo de dicha corrosión puede apreciarse en la siguiente imagen.

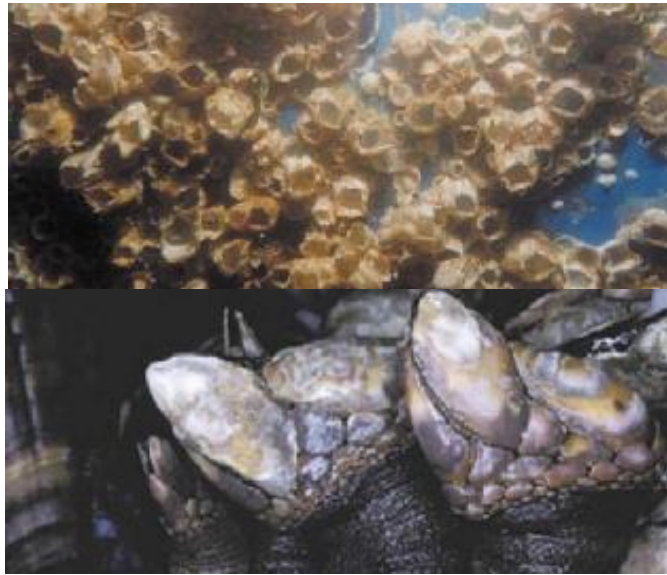
Figura 3.10: Fouling tipo animal

1. Percebes: son el mayor representante del fouling animal. Este tipo tiene una gran adhesión a la superficie en contacto, lo que provoca una complicada limpieza de los mismos. Además tienen una gran tendencia a la cohesión con otros tipos de especies lo que provoca un aumento del fouling. Cabe añadir que si no se realiza una perfecta limpieza de este tipo de fouling, los residuos del mismo van a provocar un aumento del problema en lugar de una solución.

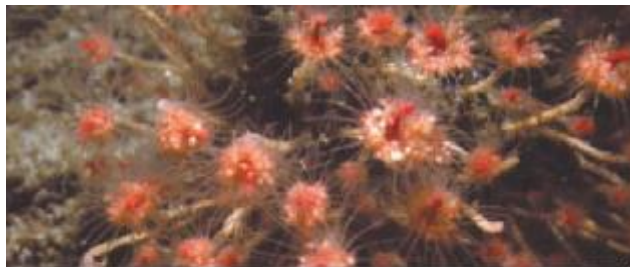
Figura 3.11: Hidroideos

2. Hidroideos: tienen una apariencia similar a una planta y viven en colonias ubicadas normalmente en el fondo de los buques donde son normalmente confundidos por algas marinas. Aunque debido a los reducidos niveles de luz que inciden sobre el fondo del casco se podría tomar la asunción de que se trata de fouling y no de algas marinas.

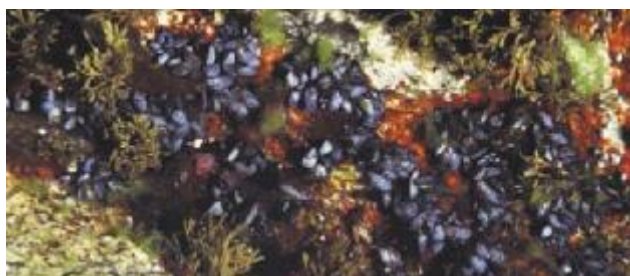
Figura 3.12: Moluscos

3. Moluscos: este tipo de fouling animal tiene duras conchas pero su adhesión a las estructuras sumergidas es débil por lo que su tendencia de aparición está más ligada a estructuras marinas estáticas que a buques en movimiento.

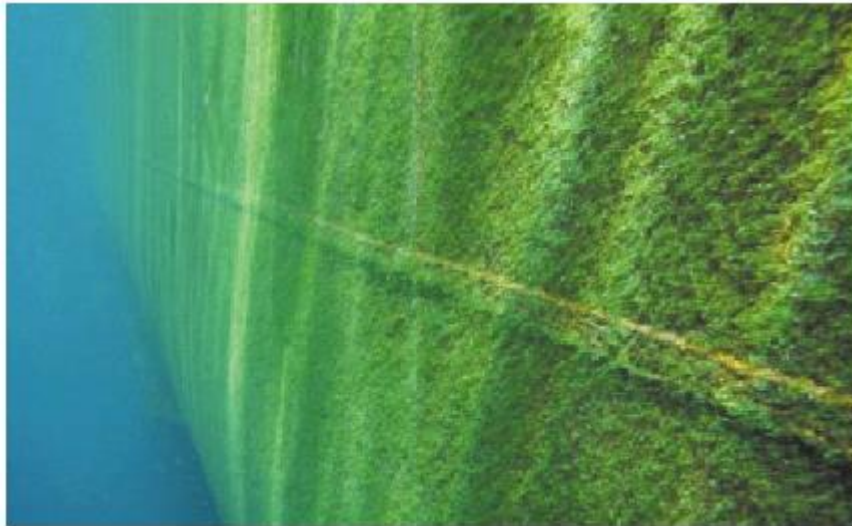
Figura 3.13: Fouling tipo planta

4. Fouling tipo planta: de este tipo los más comunes en los cascos de los buques son las algas marinas marrones *Ectocarpus* spp. Y las algas marinas verdes *Enteromorpha* spp. comúnmente denominada césped marino debido a su similitud con éste. Suele producirse en las zonas del casco donde la incidencia de la luz es notable, por lo que no se verá en el fondo del casco de los buques pero si en las zonas próximas al nivel del agua.

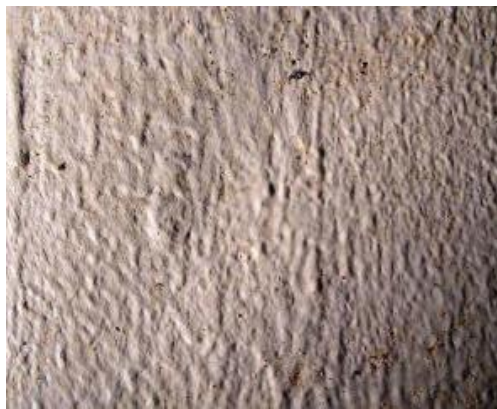
Figura 4.1: Fallo del recubrimiento tipo piel de naranja

1. Arrufo: se produce generalmente en superficies verticales donde la aplicación de la pintura se realiza con un espesor reducido o cuando la boquilla de aplicación está muy cerca de la superficie o se mantiene en la misma posición y ubicación por un periodo de tiempo elevado.
2. Piel de naranja: la superficie parece como picada y luce como la piel de naranja, de ello su nombre. Está causado por el uso de disolventes no propicios para el recubrimiento en cuestión, por el uso de una técnica de aplicación incorrecta o por un sobre-espesor de la pintura.

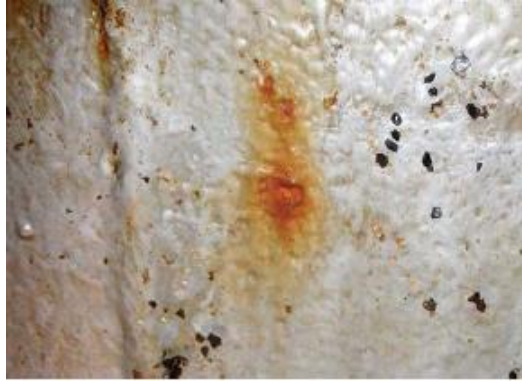
Figura 4.2: Fallo del recubrimiento debido a la falta de adhesión

3. Agrietamiento: este tipo de fallo se da lugar cuando la aplicación de la pintura da lugar a un recubrimiento muy fino, y cuando debido a las tensiones internas ocasionadas por el secado y curado de la pintura se dan lugar puede ocasionar el agrietamiento del recubrimiento.
4. Falta de adhesión: se dan lugar en zonas o áreas de pequeña superficie en las cuales no se consigue la correcta adhesión de la pintura debido a una contaminación superficial como puede ser los restos de aceite en la superficie de la estructura. El mayor problema de este tipo de fallo o defecto es que la corrosión se originará principalmente en dichas zonas.

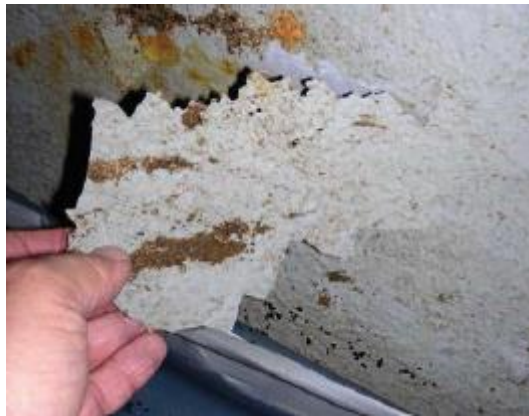
Figura 4.3: Fallo del recubrimiento debido al sobre-espesor

5. Sobre-espesor: este fallo es debido a que la aplicación de pintura excede el máximo límite de espesor del recubrimiento determinado por el fabricante, dando lugar a que se produzca su extracción o bien caiga por si solo como si se pelara el recubrimiento.

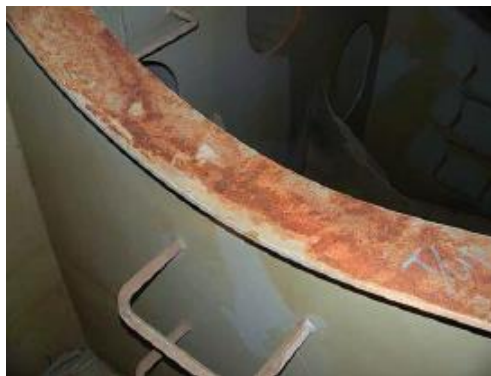
Figura 4.4: Fallo del recubrimiento debido a la falta de material

6. Falta de material: ocurre cuando el espesor de la pintura aplicada es menor al diseñado para dicha superficie.

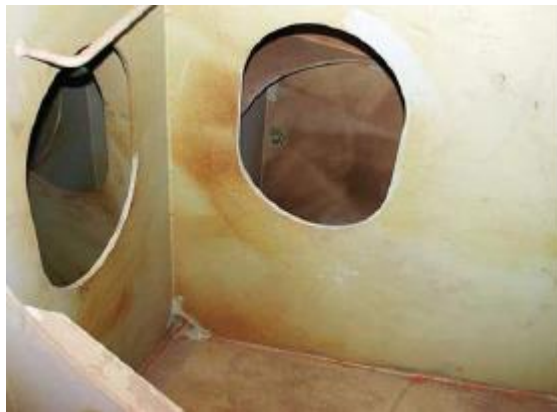
Figura 4.5: Fallo del recubrimiento debido a inclusiones de granalla

7. Inclusiones de granalla: si no se produce una correcta limpieza de la superficie después de los procesos de granallado o si los residuos de este son depositados en una superficie cercana donde la superficie pintada requiere de otra capa, se producirán inclusiones de granalla en el recubrimiento.

Esto dará lugar a la corrosión de las inclusiones cuando éstas entren en contacto con el agua, dando lugar a que el recubrimiento se vea forzado a despegarse del acero. Si por ejemplo, las inclusiones se dan entre las distintas capas de recubrimiento, en lugar de despegarse todo el recubrimiento lo haría solo las capas superiores del mismo.

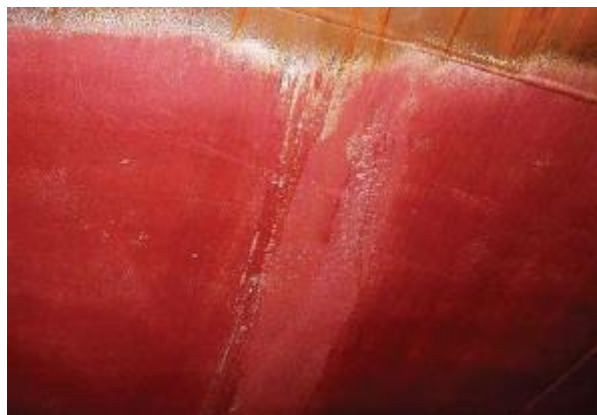
8. Error humano en la aplicación: el error humano puede darse por diversos factores, como pueden ser, la elección de un tipo de pintura inapropiado, una mezcla no propiamente realizada o la aplicación de la misma fuera de su vida útil. O bien, la aplicación de la pintura o recubrimiento fuera de los estándares apropiados para su aplicación o debido a otros procesos, como la limpieza de la superficie realizada antes de que se produjera el secado y curado total del recubrimiento:

Figura 4.6: Fallo del recubrimiento debido al error humano

Figura 4.6: Fallo del recubrimiento debido al error humano – Pg 47

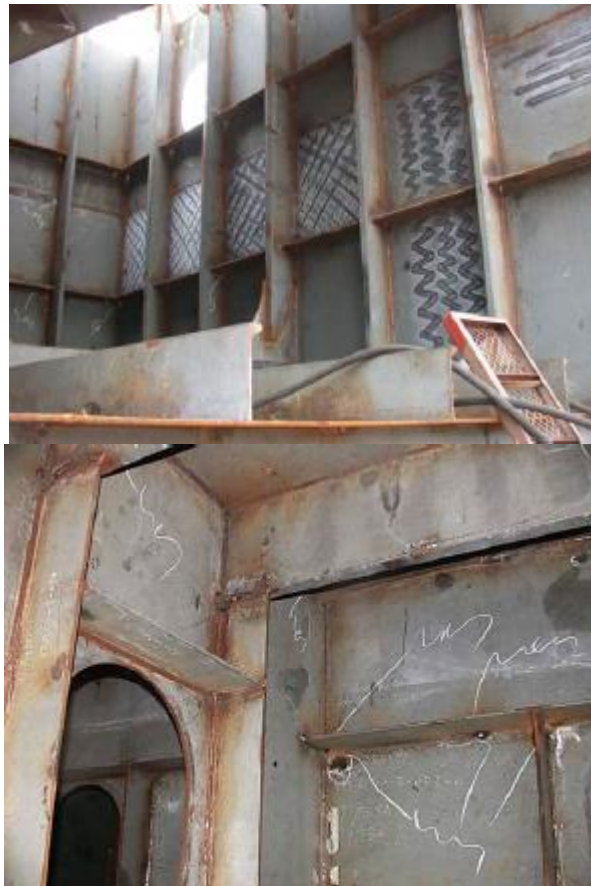
1. Fallo en la imprimación de taller: una vez es aplicada en el metal, este está sujeto a diferentes procesos de fabricación tales como el cortado, el curvado, la soldadura, la preparación de bordes y perfiles, etc., que provocan diferentes daños mecánicos sobre éste. Además de los daños mecánicos se pueden producir contaminaciones de la superficie por adhesión de grasas, aceites, suciedades, etc. Cuando se expone a la atmosfera, particularmente bajo condiciones de humedad o en zonas en contacto con el agua u otros líquidos, la corrosión de cualquier parte expuesta del metal empezará, el zinc que contiene el recubrimiento empezará a corroerse en beneficio del metal.

Pasado cierto periodo de tiempo todo el zinc que contiene el recubrimiento habrá sido corroído en beneficio del metal, y producirá sales de zinc blancas en los ejes y las soldaduras se corroerán dando lugar a óxido de hierro rojo.

Figura 4.7: Fallo en la imprimación de taller

Figura 4.7: Fallo en la imprimación de taller – Pg 49

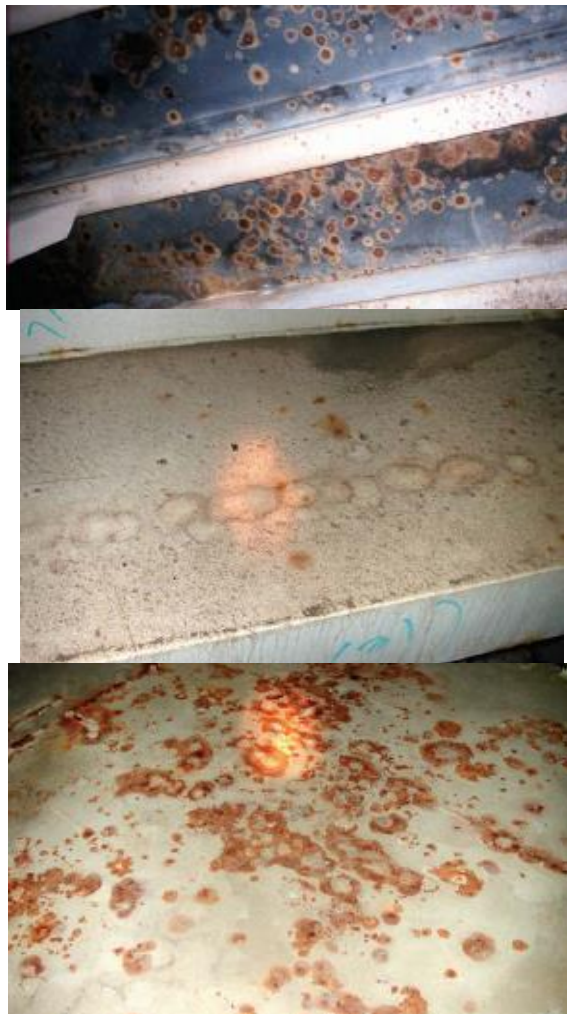
2. Manchas de corrosión: este tipo de fallo ocurre cuando se produce una acumulación de agua residual u otros líquidos, en zonas tales como las partes superiores de los tanques de lastre o en planchas bajo cubierta. Otras zonas típicas dónde suele ocasionarse es en la parte superior de los longitudinales o cuadernas.

El agua se acumula en las zonas horizontales de los refuerzos de la estructura, debido al diseño de los refuerzos y su ubicación. Otra zona de ubicación de este fallo es en las zonas del fondo del casco, en las que se acumulará el agua debido al trimado del buque, un drenaje no suficiente y debido a los agujeros en los refuerzos y las intersecciones entre ellos.

Figura 4.8: Fallo del recubrimiento tipo manchas de corrosión

Figura 4.8: Fallo del recubrimiento tipo manchas de corrosión – Pg 50

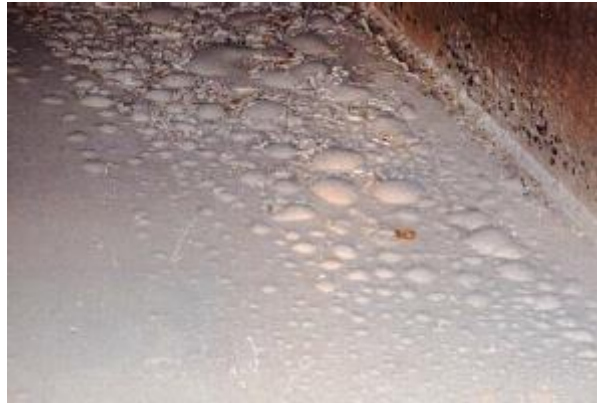
3. Erupciones en el metal: se producen erupciones con forma de ampollas en la superficie del metal o bien entre sus distintas capas del recubrimiento (caso menos usual). Son originadas por contaminación iónica en el sustrato, previamente a la aplicación del recubrimiento, o bien debido a material soluble filtrado desde el recubrimiento a la superficie exterior. El agua en el interior de la ampolla es conducida hacia fuera a través del recubrimiento, y cuando la

presión osmótica de la misma se equipara a la adhesión del recubrimiento se produce el crecimiento de la ampolla.

Figura 4.9: Fallo del recubrimiento tipo erupciones en el metal

Figura 4.9: Fallo del recubrimiento tipo erupciones en el metal – Pg 51

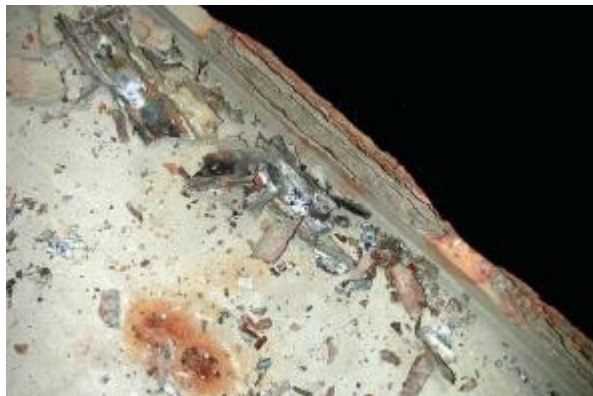
4. Ruptura del recubrimiento en los bordes: se produce la ruptura del recubrimiento en las zonas de los bordes de los refuerzos y en las zonas próximas a los recortes en la estructura, como pueden ser los pasos de hombre, escotillas, etc.

Algunas de las causas de este tipo de fallo pueden ser la aparición de una tensión superficial en la capa de la pintura aún húmeda, una elevada velocidad de aplicación del recubrimiento o una preparación de superficies inadecuada o insuficiente.

Figura 4.10: Fallo del recubrimiento tipo ruptura en los bordes

Figura 4.10: Fallo del recubrimiento tipo ruptura en los bordes – Pg 51

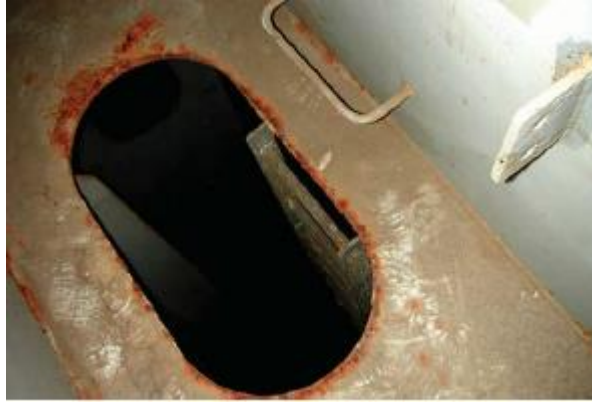
Figura 4.11: Fallo del recubrimiento tipo ruptura en las zonas próximas a los recortes de la estructura

Figura 4.11: Fallo del recubrimiento tipo ruptura en las zonas próximas a los recortes de la estructura – Pg 52

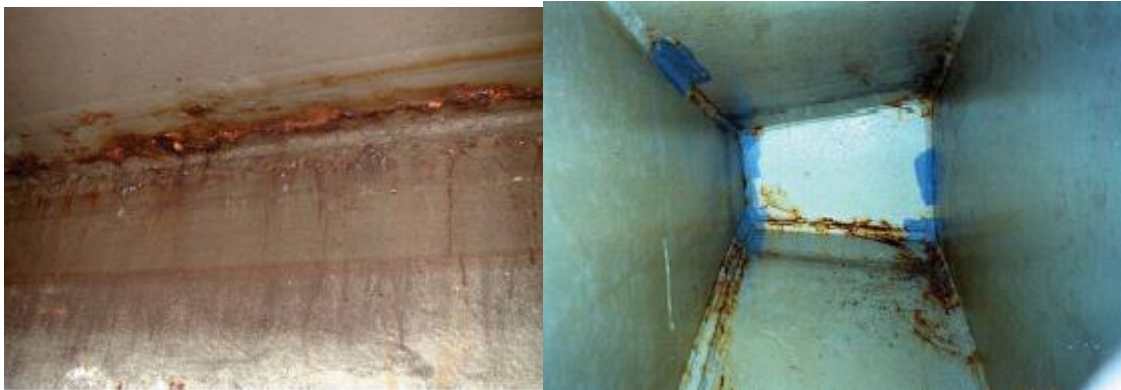
5. Corrosión en la soldadura: como sucede en los bordes de la estructura, las soldaduras son otras zonas propensas al desconchamiento del recubrimiento y por ende a la corrosión del metal base. Los dos tipos básicos de corrosión que se dan lugar en las soldaduras son:

- La corrosión se inicia en ambos costados del cordón de soldadura, dentro de la zona térmicamente afectada, y el óxido se produce desde el proceso de soldadura.
- Este segundo tipo de corrosión ocurre más cercano a la soldadura y está asociado a una falta de limpieza en la superficie previa a la aplicación del recubrimiento.

Figura 4.12: Fallo del recubrimiento debido a la corrosión de la soldadura

Figura 4.12: Fallo del recubrimiento debido a la corrosión de la soldadura – Pg 52

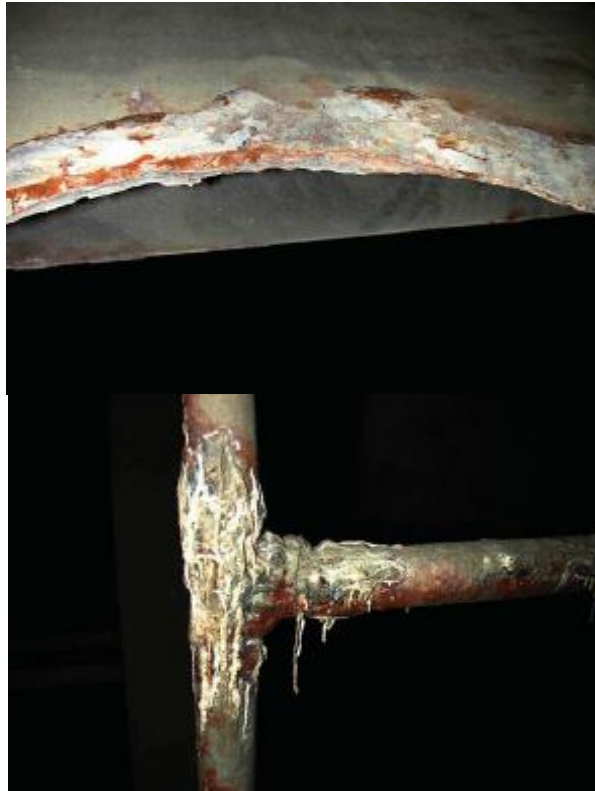
6. Depósitos calcáreos: la presencia de ánodos de sacrificio en los tanques de lastre da lugar a la formación de iones de hidroxilo en la interfase del metal con el recubrimiento, previniendo la corrosión. Como repercusión se forman los denominados depósitos calcáreos.

Los depósitos calcáreos se originan parcialmente por la reacción del dióxido de carbono con los iones de hidroxilo y también, debido a la deposición de carbonatos semi-soluble depositados debido al agua de mar en contacto con la estructura.

Figura 4.13: Fallo del recubrimiento debido a depósitos calcáreos

Figura 4.13: Fallo del recubrimiento debido a depósitos calcáreos – Pg 53

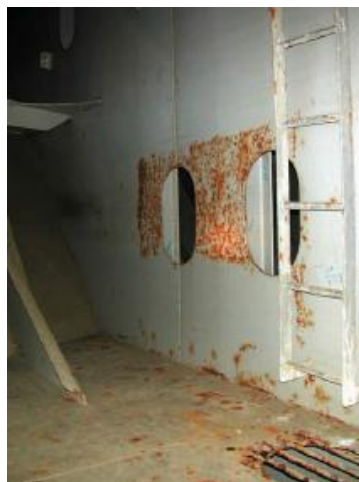
7. Mala preparación de superficies: una preparación inadecuada de la superficie a tratar es uno de los principales fallos en los recubrimientos, pero si añadimos además una pobre aplicación de los mismos o con un espesor reducido, se puede producir corrosión y abrasión.

Figura 4.14: Fallo del recubrimiento debido a una mala preparación de superficies

Figura 4.14: Fallo del recubrimiento debido a una mala preparación de superficies – Pg 53

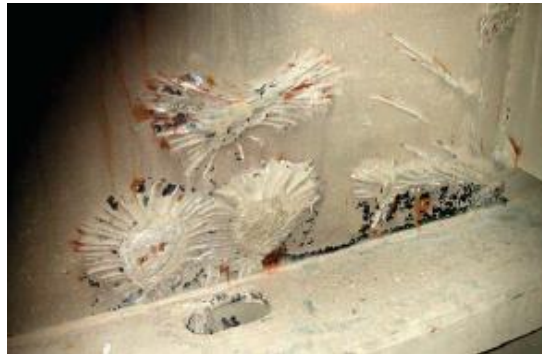
8. Daños por impacto inverso: puede darse lugar en zonas como los tanques de lastre debido a un impacto intenso y fuerte desde fuera del mismo tanque. Se da comúnmente en graneleros, principalmente en las zonas del doble fondo debido al impacto de la maquinaria utilizada para la extracción de la materia transportada.

Figura 4.15: Fallo del recubrimiento debido a daños por impacto

Figura 4.15: Fallo del recubrimiento debido a daños por impacto – Pg 54

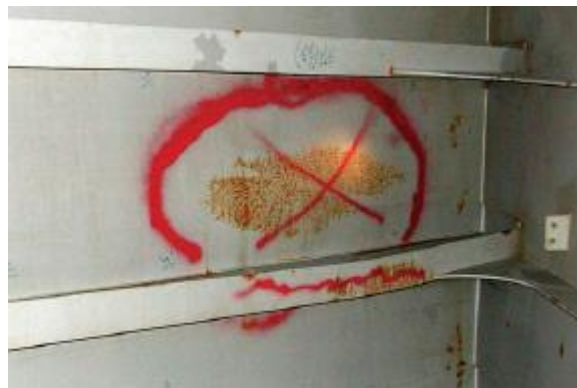
Otras zonas en las que se dan lugar dichos daños son las zonas contiguas a las áreas de empuje de los remolcadores, las zonas de los costados en las que inciden las olas y pueden llegar a incidir objetos que se encuentren en la mar. Pero estos tipos de daños son menores que los citados anteriormente y su repercusión sobre el recubrimiento es también menor.

Figura 4.16: Fallo del recubrimiento en la zona del área de empuje de los remolcadores

Figura 4.16: Fallo del recubrimiento en la zona del área de empuje de los remolcadores – Pg 54

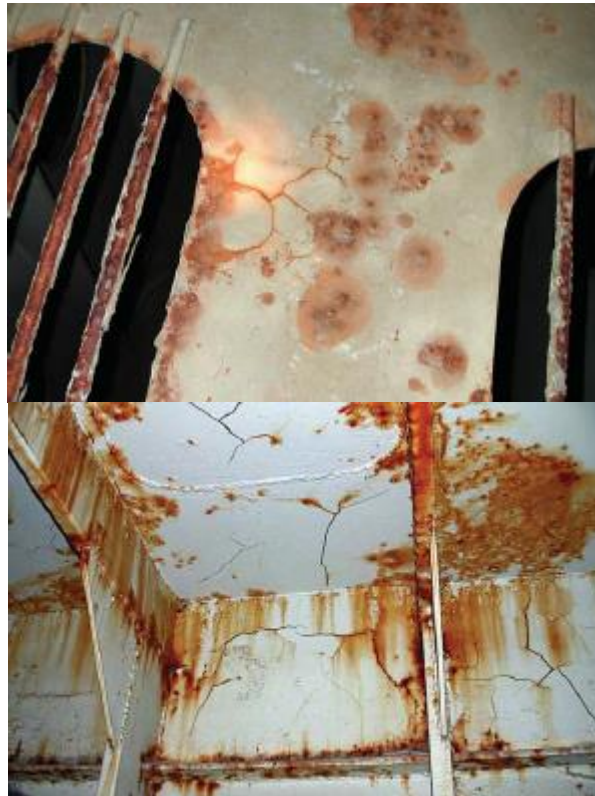
9. Agrietamiento: es generalmente el resultado de un espesor insuficiente de una capa del recubrimiento en una zona donde el recubrimiento tiene un espesor considerable. Otra razón es la aparición de elevadas tensiones internas que provocan el agrietamiento en los recubrimientos con un espesor elevado.

Figura 4.17: Fallo del recubrimiento tipo agrietamiento

Figura 4.17: Fallo del recubrimiento tipo agrietamiento – Pg 55

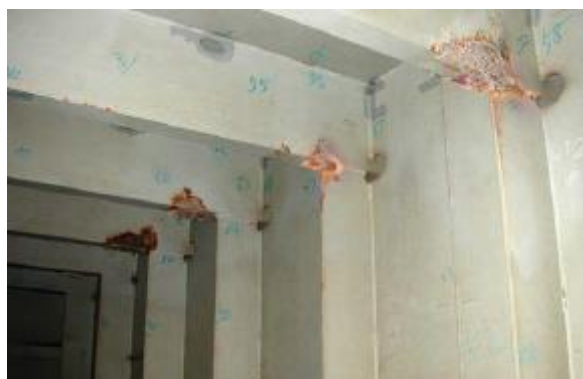
10. Debido a tensiones en la estructura: la corrosión puede aparecer en zonas donde los niveles de tensiones en la estructura sean elevadas, como por ejemplo en las uniones de los refuerzos longitudinales y transversales. Se pueden identificar por su localización o por la aparición del mismo tipo de fallo en el mismo lugar de la estructura.

Figura 4.18: Fallo del recubrimiento debido a tensiones internas

Figura 4.18: Fallo del recubrimiento debido a tensiones internas – Pg 55

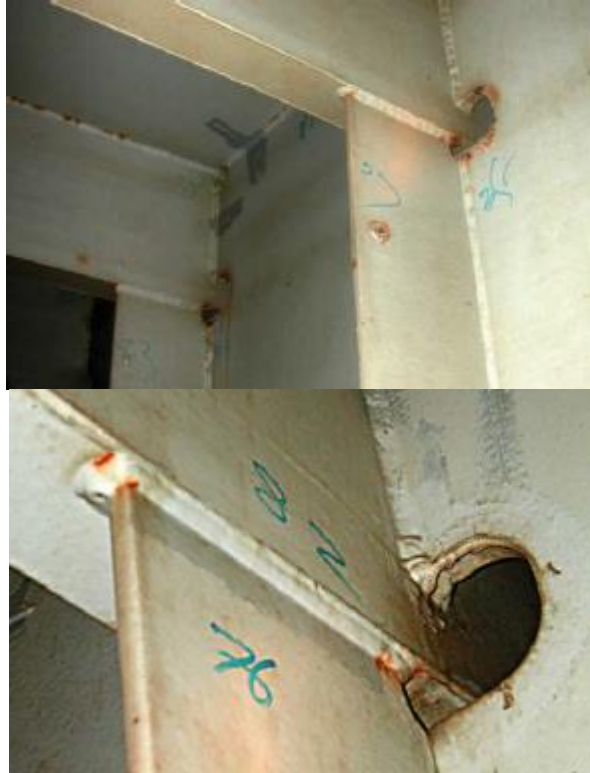
También pueden darse lugar en las zonas próximas a aperturas o en las soldaduras.

Figura 4.19: Fallo del recubrimiento debido a tensiones en las zonas próximas a aperturas o soldaduras

Figura 4.19: Fallo del recubrimiento debido a tensiones en las zonas próximas a aperturas o soldaduras – Pg 56

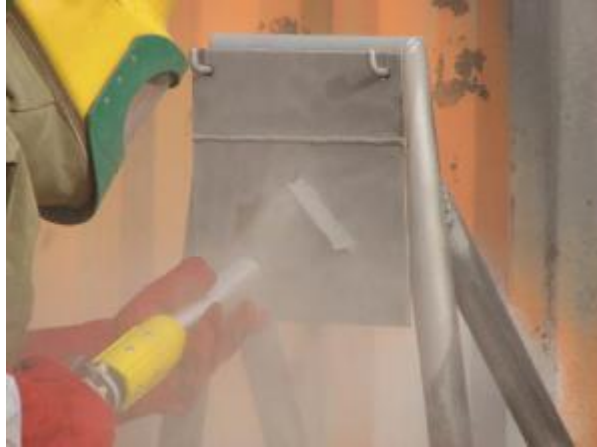
Para la aplicación de este método, hay que realizar previamente unas tareas de limpieza de la superficie que implican una limpieza de las posibles acumulaciones de aceites y grasas, restos de soldaduras y salpicaduras de las mismas. Además después de haberse aplicado requiere de un postproceso de limpieza que permite eliminar la suciedad y el polvo generados por su uso.

Características tales como el tipo de material abrasivo y las características del chorro abrasivo deberán seleccionarse en función de la zona a preparar y del correspondiente material.

Figura 6.1: Limpieza por abrasión

Figura 6.1: Limpieza por abrasión – Pg 75

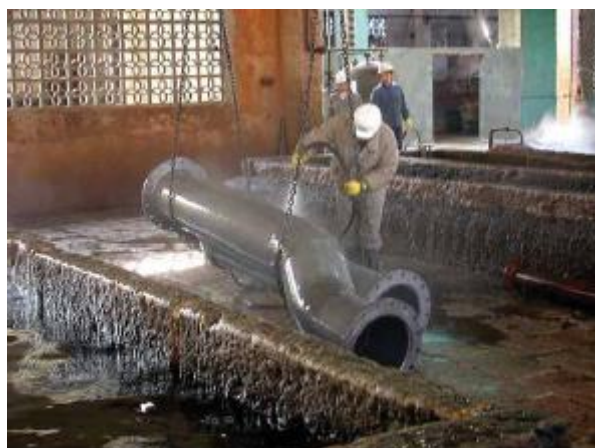
El decapado consiste en un baño en ácido de la pieza a tratar, normalmente es utilizado en elementos de restringido tamaño, no en un área completa. Los elementos que se suelen tratar con el decapado son tuberías, pequeños elementos estructurales como refuerzos, etc.

Debido al baño en ácido del elemento a tratar, se requiere de una limpieza adecuada para asegurarse de la correcta adhesión del recubrimiento.

Figura 6.2: Proceso de decapado ácido

Figura 6.2: Proceso de decapado ácido – Pg 77

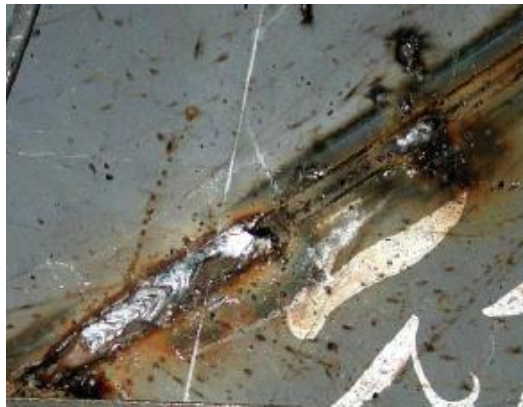
Los procesos de soldadura provocan deposiciones en el metal adyacente, humos y escoria, que deben ser removidos para asegurar la correcta preparación de superficies.

La escoria debe ser removida manualmente, mientras que las deposiciones debidas a la soldadura deberán eliminarse mediante técnicas mecánicas. Si no se eliminan de forma adecuada, éstas provocarían una superficie irregular, que da lugar a una insuficiente protección del metal al aplicarse la pintura.

Figura 6.3: Preparación de soldaduras

Figura 6.3: Preparación de soldaduras – Pg 78

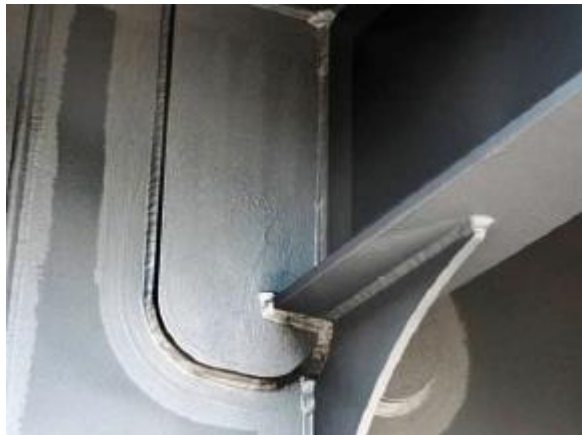
1. Aplicación mediante brocha: es un método de baja velocidad de aplicación que se utiliza para pintar zonas de difícil acceso, como pueden ser aligeramientos, uniones de refuerzos, etc; y para la aplicación de imprimaciones en las que se requiera una gran penetración. Además de su uso durante las labores de mantenimiento para pequeños retoques en la estructura.

Figura 6.5: Aplicación mediante brocha en zonas de difícil acceso

Figura 6.5: Aplicación mediante brocha en zonas de difícil acceso – Pg 79

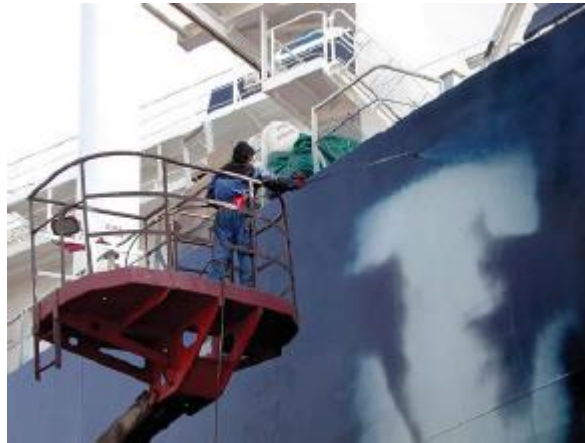
3. Aplicación mediante spray convencional: se utiliza para pinturas con baja viscosidad, con un equipamiento con un coste reducido y simple. Se basa en la atomización de la pintura mediante el uso de aire a presión, que junto con la pintura atomizada forma una especie de neblina de pintura que se transporta hasta la superficie a pintar gracias a la presión ejercida por el aire inyectado. Hay que regular correctamente el aire a inyectar para evitar posibles imperfectos en el recubrimiento.
4. Aplicación mediante spray sin aire: es el método más eficiente para la aplicación de recubrimientos, ya que permite una aplicación a gran escala con una velocidad elevada. Su funcionamiento se basa en la atomización de la pintura, para su aplicación, mediante el uso de presión hidráulica al hacer pasar la pintura por una boquilla a presión.

Figura 6.6: Aplicación del recubrimiento mediante spray sin aire

Figura 6.6: Aplicación del recubrimiento mediante spray sin aire – Pg 80

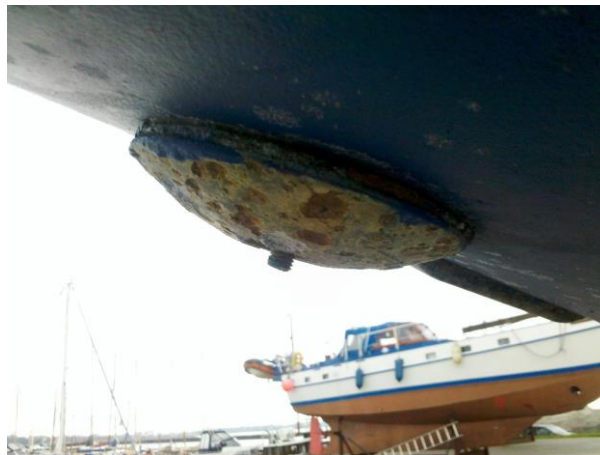
Este tipo de protección catódica se basa en la aplicación de una protección pasiva, es decir, se coloca una pieza de un material más cargado electroquímicamente (potencial electroquímico más negativo) sobre la superficie a proteger que está en contacto con el electrolito.

Debido a la aplicación de dichos ánodos de sacrificio sobre la superficie del metal, cuando se inicia el proceso de corrosión y de acorde a lo explicado en el capítulo 3, en lugar de producirse la corrosión de la estructura se produce la corrosión del ánodo, al poseer este un potencial electroquímico más negativo. Es decir, se utilizan materiales con diferentes potenciales galvánicos para que la reacción de corrosión se produzca entre éstos y el electrolito, dejando al margen de la reacción de corrosión el metal a proteger.

Figura 7.1: Ánodo de sacrificio

Figura 7.1: Ánodo de sacrificio – Pg 85

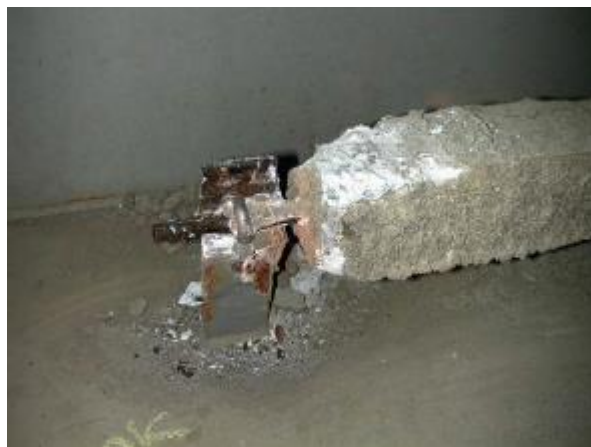
La solución a esto es el efecto indirecto que se produce, antes de que el tanque se seque por completo, debido a que los iones de hidroxilo mantienen a la superficie pasiva y los depósitos calcáreos actúan como una barrera para el oxígeno, evitando así los procesos de corrosión que se ocasionarían en circunstancias normales.

Entonces, podemos decir que la eficacia de estos sistemas está ligada a la condición de los ánodos de sacrificio y a la producción y condición de los depósitos calcáreos que se forman.

Figura 7.2: Ánodo de sacrificio ubicado en los tanques de lastre

Figura 7.2: Ánodo de sacrificio ubicado en los tanques de lastre – Pg 86

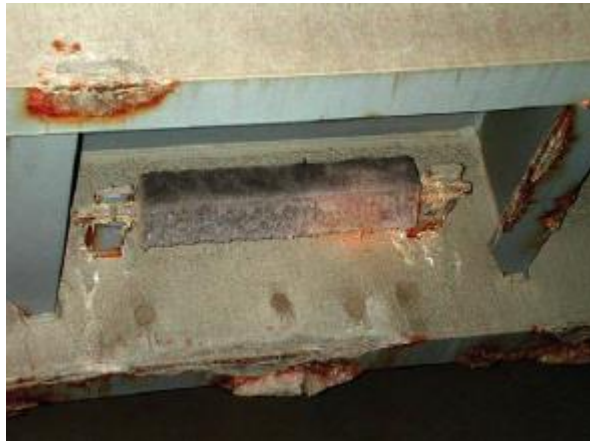
Si por ejemplo, el posicionamiento de los ánodos de sacrificio no es el correcto, se puede llegar a provocar serias abrasiones en los recubrimientos de las estructuras a proteger, así como en sus alrededores, como pueden ser los refuerzos estructurales,

sistemas de tuberías, tanques de lastre, etc. Como puede observarse en la siguiente fotografía.

Figura 7.3: Corrosión producida por una mala colocación del ánodo de sacrificio

Figura 7.3: Corrosión producida por una mala colocación del ánodo de sacrificio – Pg 87

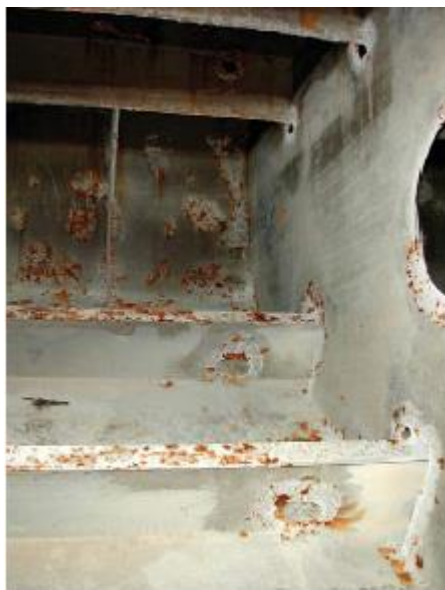
Y si los recubrimientos aplicados en la estructura empiezan a fallar y se forman depósitos calcáreos en las paredes del tanque, el estado en el que se puede encontrar el tanque puede ser tal que el siguiente.

Figura 7.4: Corrosión en las paredes del tanque

Figura 7.4: Corrosión en las paredes del tanque – Pg 87

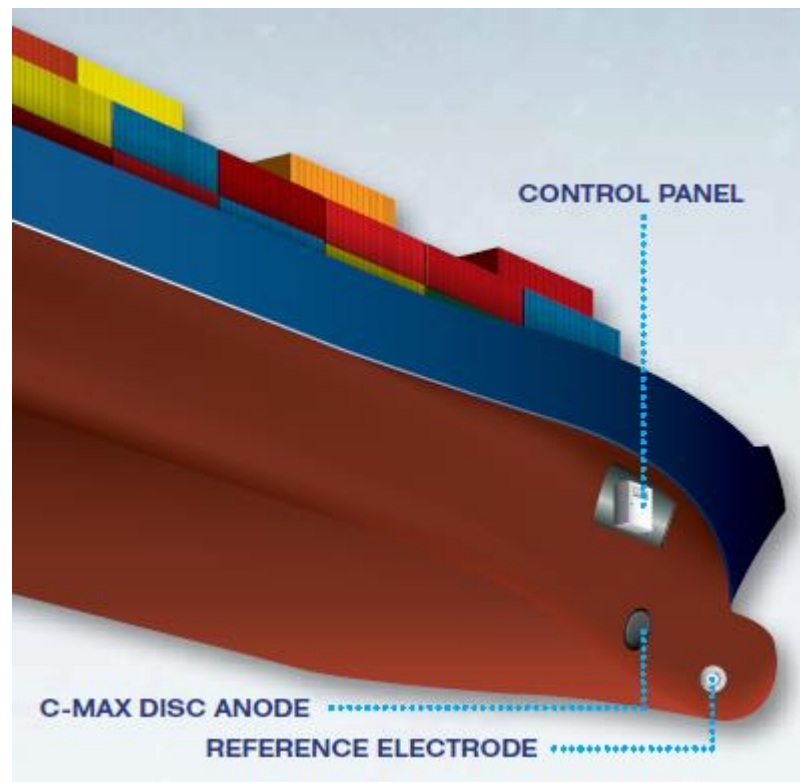
Este tipo de sistema tiene la ventaja de que detecta de forma automática el potencial eléctrico en la interfase casco/agua de mar y regula la corriente en los ánodos.

A diferencia de los ánodos de sacrificio, el ICCP utiliza en detrimento de los ánodos consumibles un ánodo de material no consumible, como puede ser titanio con un recubrimiento de óxido de metales mixtos. Además cuenta con electrodos de referencia en la proa y popa del casco del buque, que permiten la monitorización de la polarización del voltaje producido en el casco y que permite así regular la corriente impresa en los ánodos. Las lecturas recogidas por los electrodos de referencia son recogidas por el panel de control que ajusta de manera automática la corriente del circuito.

Figura 7.5: Ubicación sistema ICCP

Figura 7.5: Ubicación del sistema ICCP – Pg 88

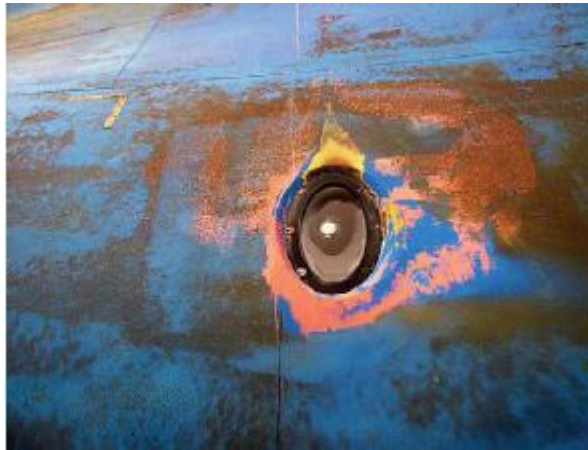
Es importante que las áreas que rodean los ánodos tengan una aplicación mayor de pintura, evitando así o al menos reduciendo los problemas de abrasión que se pueden ocasionar en estas zonas.

Figura 7.6: Problemas de abrasión en las zonas contiguas al ánodo

Figura 7.6: Problemas de abrasión en las zonas contiguas al ánodo – Pg 89

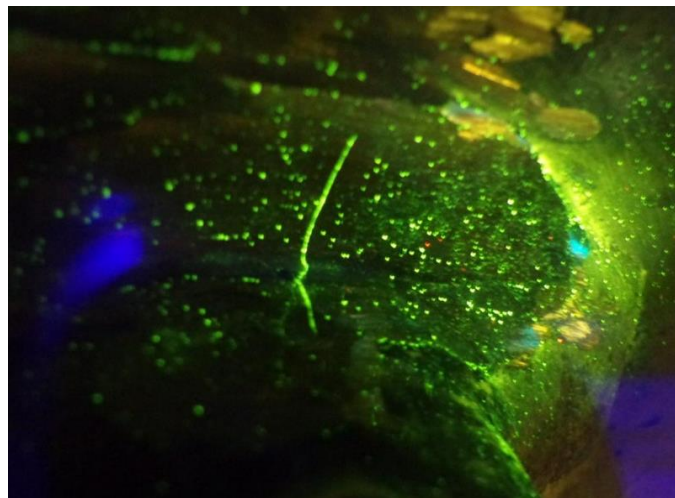
Este tipo de ensayo se basa en la aplicación de partículas magnéticas sobre la superficie a examinar. Una vez esparcidas sobre la superficie, se procede a la magnetización del material. Dando lugar a una acumulación de las partículas en las zonas donde hay fisuras o discontinuidades en las soldaduras, debido a las perturbaciones producidas en las líneas del campo magnético. Es decir, el ensayo por partículas magnéticas nos permite detectar fisuras y discontinuidades superficiales y subsuperficiales.

Figura 8.1: Ensayo por partículas magnéticas

Figura 8.1: Ensayo por partículas magnéticas – Pg 93

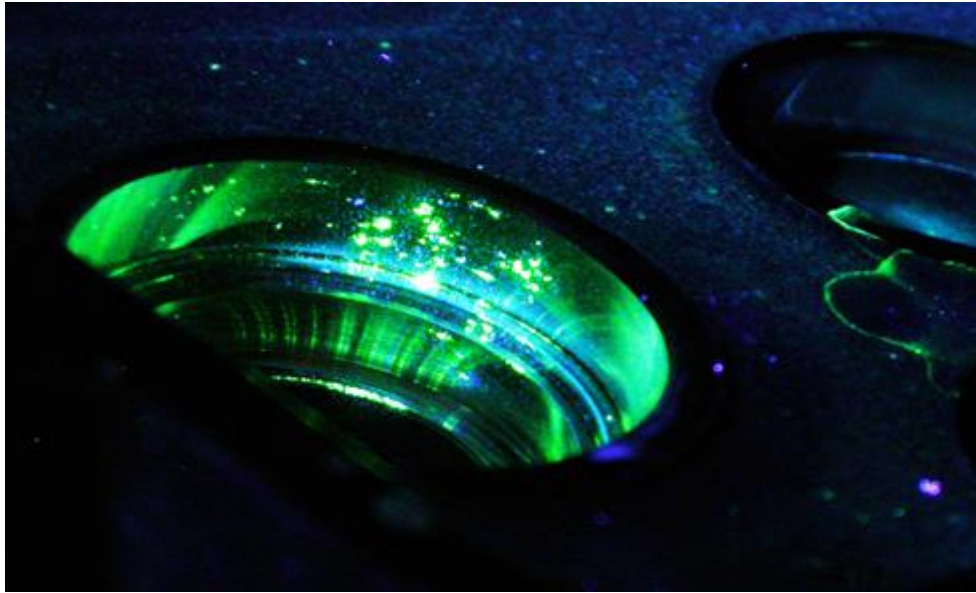
El ensayo por líquidos penetrantes permite la detección de las discontinuidades superficiales. Su procedimiento se basa en la aplicación de un líquido que penetra por capilaridad en la superficie del material a analizar, en las zonas en las que hay discontinuidades. Una vez limpiada la superficie del material, el líquido que queda retenido en él, exuda, permitiendo la detección de forma visual de los defectos en la superficie.

Figura 8.2: Ensayo por líquidos penetrantes

Figura 8.2: Ensayo por líquidos penetrantes – Pg 95

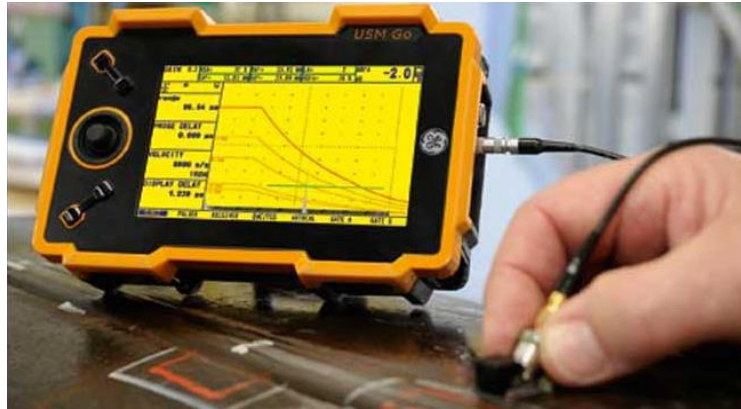
Se basa en la utilización de pulsos ultrasónicos que se reflejan en cualquier superficie que encuentran a su paso. El emisor de ultrasonidos emite las ondas ultrasónicas que avanzan a través de la superficie a analizar, si se encuentra con una fisura o discontinuidad, produce un eco que es recogido por el osciloscopio, lo que nos permite ver los defectos en el material.

En el caso de que no hubiera ninguna fisura o discontinuidad en el elemento a analizar, la onda atravesaría completamente el elemento y el osciloscopio no recogería señal alguna.

Figura 8.3: Medidor de ultrasonidos

Figura 8.3: Medidor de ultrasonidos – Pg 96

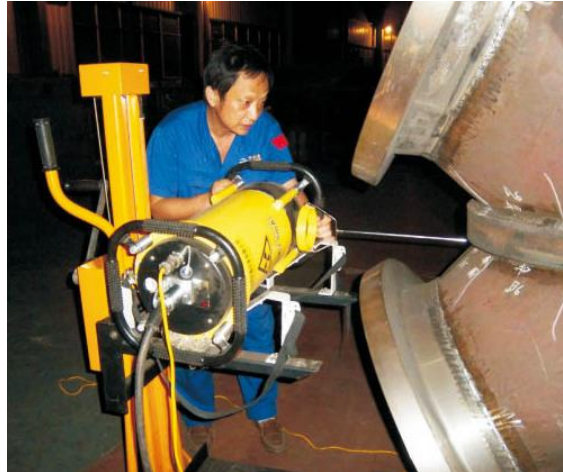
La inspección mediante el uso de rayos X o rayos gamma, se basa en obtener una imagen de la zona o área a inspeccionar mediante la emisión de dichos rayos. Cualquier tipo de defecto que pudiera haber en la zona inspeccionada se verá reflejado en la placa de la radiografía.

Figura 8.4: Máquina de rayos X

Figura 8.4: Máquina de rayos X – Pg 97

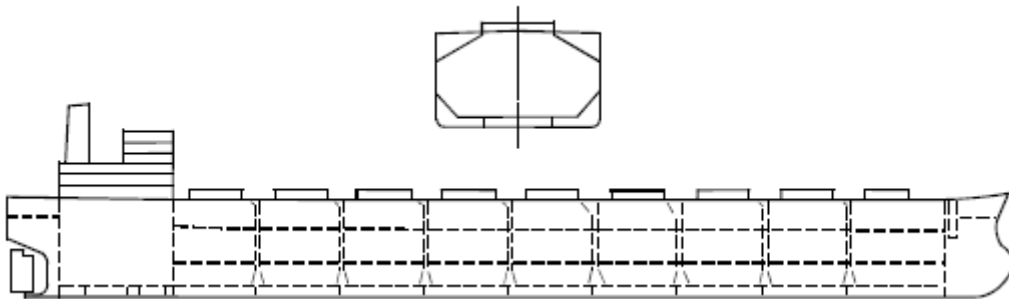
Figura 8.5: Buque granelero

Figura 8.5: Buque granelero – Pg 98
